Sree Narayana Guru College of Engineering & Technology

DETAILS OF FIELD PROJECTS

Abatement of Polluted Stretch of River Peruvamba from Eryam- Edakom Bridge to Kunnaru Bridge

Detailed Project Report

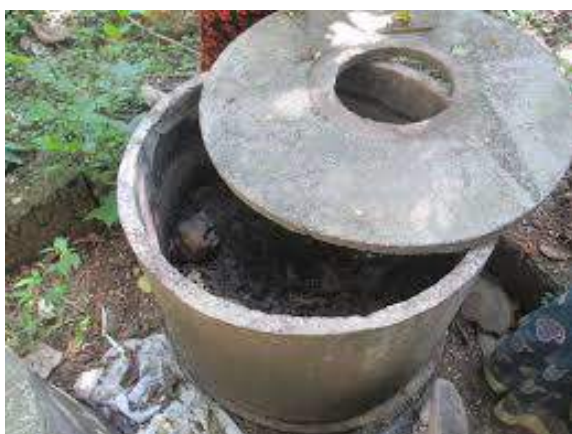
Fig 3.4 a Ring compost

Pipe compost and Ring compost installed in most of the households and household-biogas plants contribute to composting degradable solid wastes from houses.

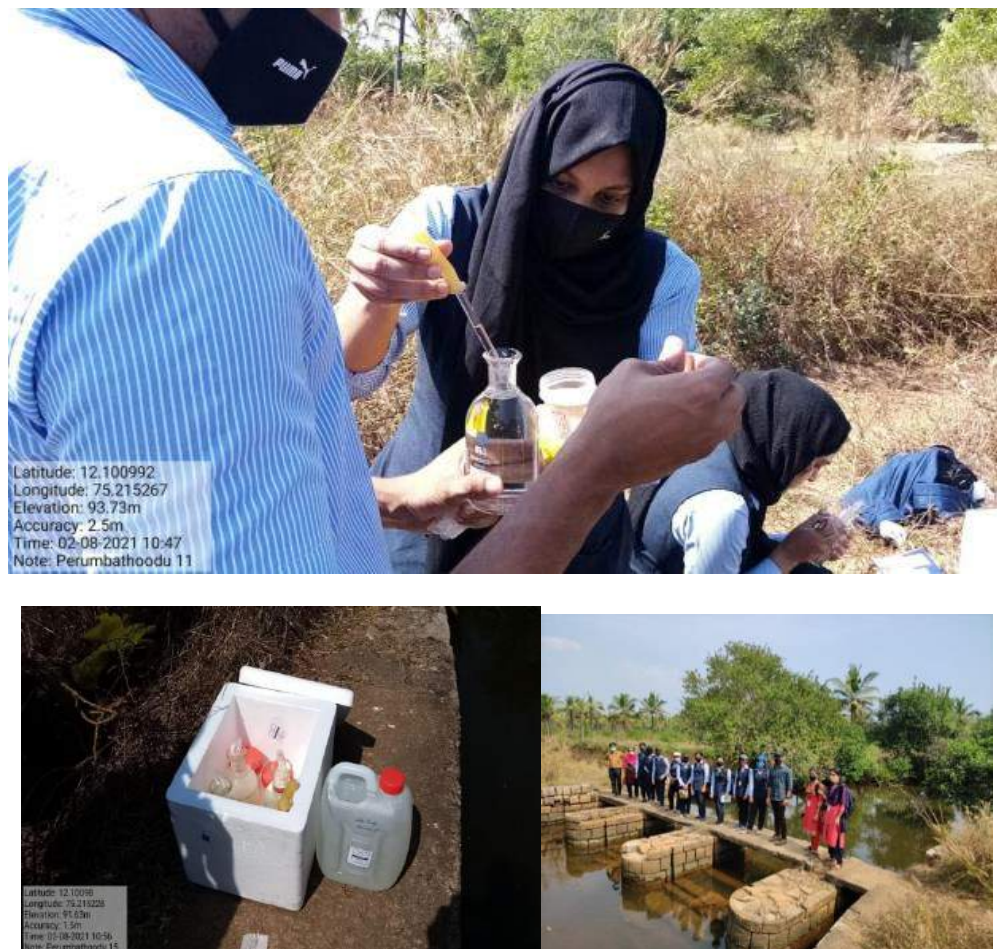
Fig 6.2.c. Water Sampling from various stations

Adhering the Standard Sampling procedure, water samples were collected from the above stations and sent to Kerala water authority Kannur for analyses on 8-Feb-2021.

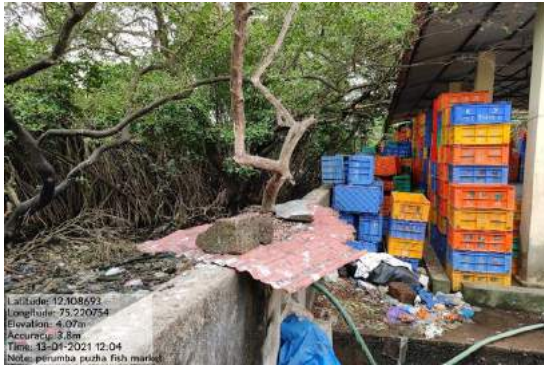
Fig 6.3.a: Behind Fish market

It is observed that no major industries except a Municipality Fish market and a Wood Industry are located along the stretches.
